Suspended Marine Litter in New Calabar/Bonny Estuary System and Amadi Creek, Rivers State, Nigeria

Arinze O. Uche^{2,3*} Babatunde, Bolaji B^{1,2,3}

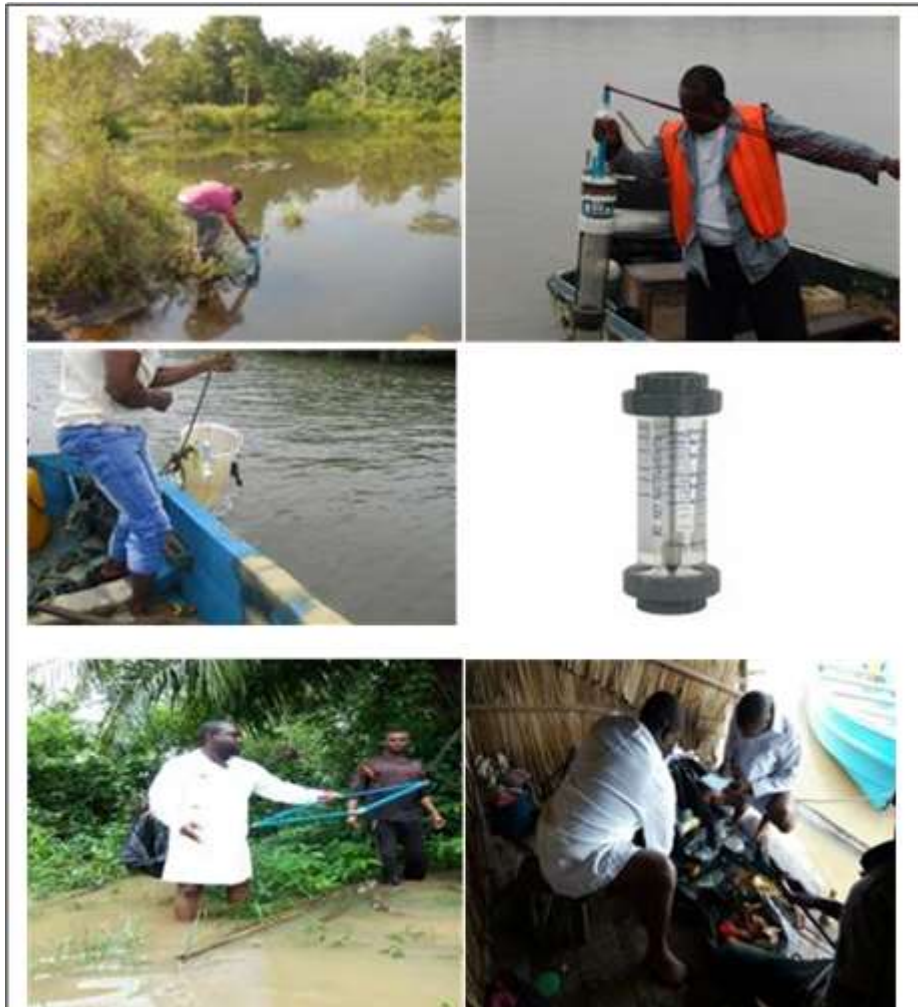
Plate 3: Instrument used during field survey

The depth of the rivers was measured using a type H1-ITL depth resounding water gun (Plate 3) and supported with a gravity corer (Plate 3).

Andrea recording current meter (RCM 9) with Acoustic Doppler current sensor 3620 was used in water current measurements (Plate 3). The current meter is self-recording and intended to be moored to measure and record the vector-averaged velocity and direction of the tidal current. The instrument features a newly developed RCM Doppler current sensor.

A quadrat technique was used to assess the amount of material. Quadrat size of 50 cm² (Plate 3) were deployed at random severally within defined area. Material found within a quadrat is collected and weighed in kilogram.

Material collected from the quadrat are spread on a 1meter nylon and sorted out into its constituents according to ASTM D5231 – 92 (2008) standard procedure (Plate 3).

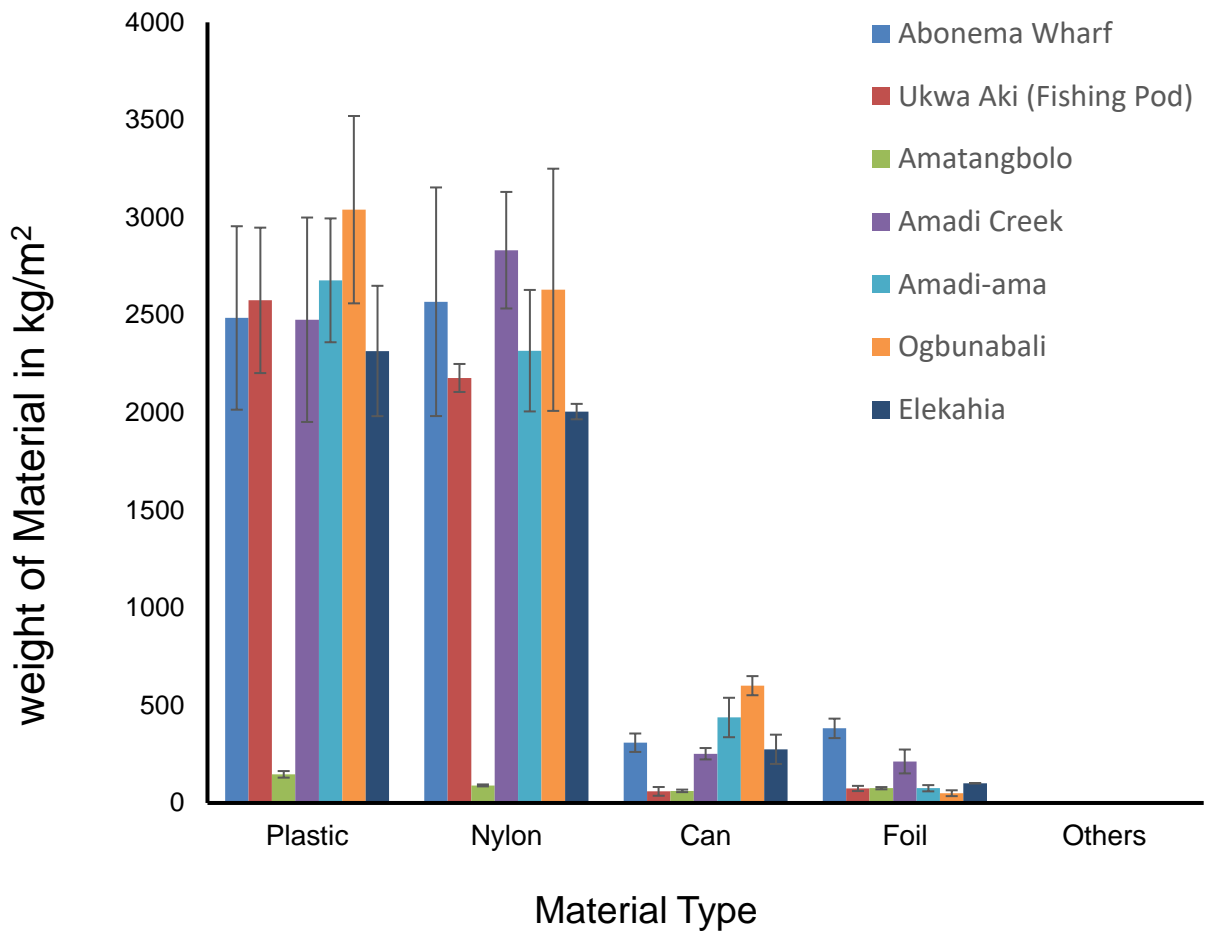
Fig 3: Mean composition of material at different sampling locations in Rivers State (SEM =n=30)

Result of the characterization of the suspended debris in creeks in Rivers State is presented in Fig. 3 – 7 and Table 3. The categories of debris comprised plastic, nylon, can and foil. Plastic recorded the highest amount in composition followed by nylon, can and foil recorded the least value across all locations Fig 3. Average weight of suspended material per square meter and per square kilometer is presented in Table 3. It ranged from the least value of 337.67 kg/m² at Amatangbolo to the highest value of 6,320.50 kg/m² at Ogbunabali. This translates to least value of 7553.33 kg/km² at Amatangbolo and the highest value of 126,410 kg/km² at Ogbunabali. Based on 20 tons capacity estimate for dumper trucks, this study location would require between 1-7 dumper trucks to evacuate the suspended debris per square kilometers Table 3.

The quality and severity of the distribution of suspended debris in Rivers State is presented in Figs 3 – 7. Foil material ranged from 35 kg/m² to 432.1 kg/m² and recorded its hotspots at Bakana, Diobu, Nkpogu, Ogbunabali, and Amadi-ama Fig. 3 and 4. Plastic ranged from 100 kg/m² to 3521 kg/m² at hotspots such as Bakana, Abonnema Wharf, Marine Base, Nkpogu, Elekahia, Ogbunabali, and Amadi-ama creeks Fig 3 and 5. Nylon ranged from 84 kg/m² to 3,256 kg/m² and its hotspots were at Diobu, Abonnema Wharf, Budu-ama, Marine base, Nkpogu and Amadi ama Fig 3 and 6. The distribution of can material ranged from over 26 kg/m² to 650 kg/m² with hotspots Diobu, Abonnema, Marine Base, Nkpogu, Amadi-ama and Ogbunabali creeks Fig. 3 and 7.
