“HIGHLAND TOWERS COLLAPSED”, THE TRAGIC STORY OF MALAYSIA!

Abstract

Highland Towers, as is collectively known, consist of three blocks 12 story high apartments named simply as Block 1, 2, and 3 respectively. It was constructed sometime between 1975 and 1978 and the residents who dwelled therein were middle income earners. Directly behind the 3 blocks was a rather steep hill with a stream flowing west, if it was allowed to follow its natural course. The attraction of this place was the natural surroundings with an extensive view of the city of Kuala Lumpur. Highland Towers collapse was caused by the instability of the pile foundation. The engineer was not considering the horizontal load during design foundation so when the rotational retrogressive slide occurs, this forward movement downhill created a surcharge load to the foundation. Since the foundation cannot resist horizontal load, it failed and as a result, the Highland Towers collapsed. Combinations of several factors were contributed to the tragedy of Highland Towers. Tragedies like this can be difficult to prevent. However, certain measures can be taken to protect buildings from landslides.

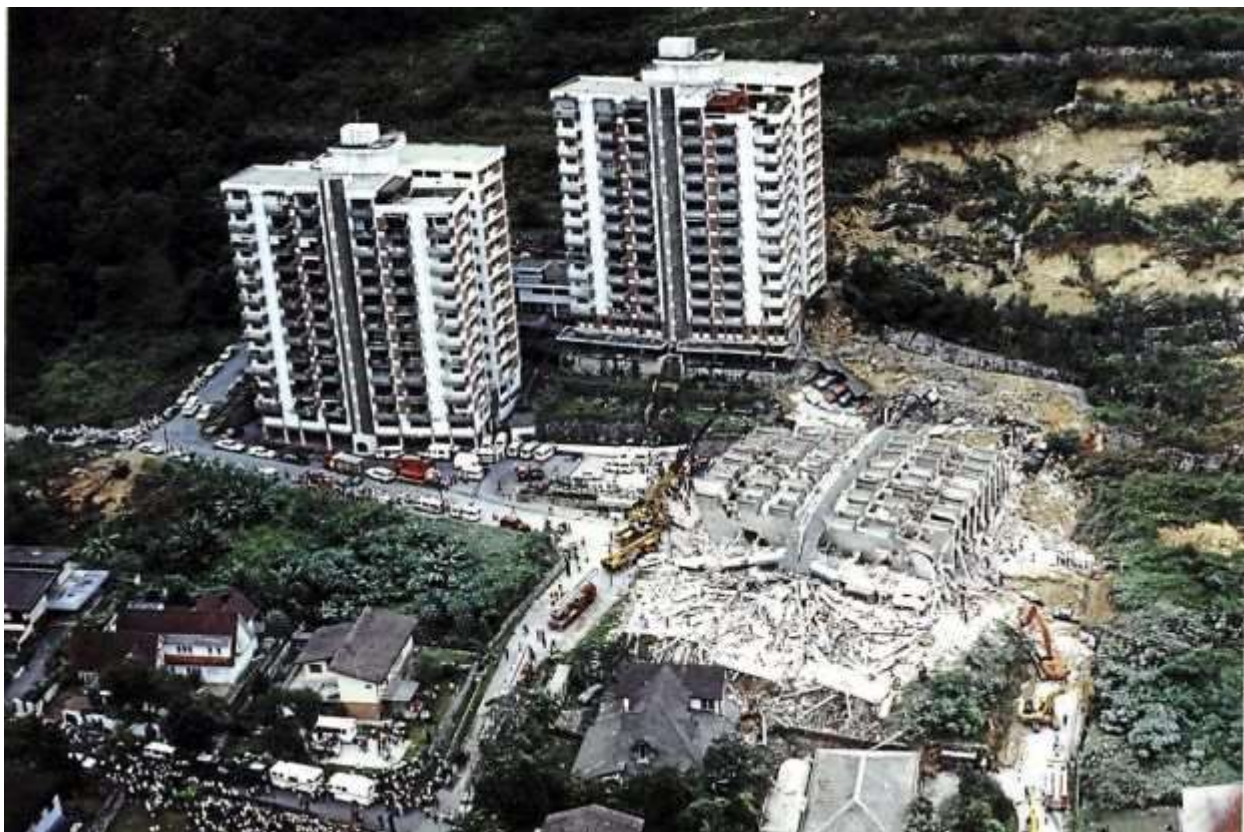
The Ulu Klang area has experienced several serious landslides since December 1993, when a Block of Highland Towers collapsed, causing a tragedy involving 48 deaths. The Highland Towers have three 12-storey blocks, constructed between 1975 and 1979 at the western base of a steeply sloped hill which was later terrace extensively in the starting of 1980s. Each block was respectively called Block 1 (built first, southern- most), Block 2 (built second, north-northwest of block 1, slightly elevated than the other two, closer in to the hill) and Block 3 (built last, northwest of block 1, west of block 2). The total length of landslide was 120 m and width of rupture surface was about 90 m involving round about 40,000 m³ of debris. Regarding this landslide the most authentic report has been produced by Ampang Jaya Town Council that (MPAJ, 1994) Highland Tower collapse main cause is inadequate drainage. From another aspect, design deficiencies are also found. The report has (MPAJ, 1994) following concluded factors responsible for this landslide (Jaapar, 2006):

- Buckling and shearing of rail piles foundation persuade by soil movement.
- Surface runoff due to improper drainage facility.
- Cut and fill slopes, rubble walls around Block I showed inadequate design (carrying safety factor <1) and poorly administered construction.
- Slope gradient is suspected to be very steep.
- No maintained drainage system along with leakage from pip.

From the computational analysis done by Prof Simon, (Nguee, 2006) revealed the facts that high wall has very low safety factor and the designed wall would fail at 5 m very simply even not including water pressure. The calculated safety factor of all those walls which were at the back of Block 1 is 1.52, even without allowing water forces at the back of the walls. It is also observed under the same study that wall composed of different size of

stones with haphazard plaster carrying no drainage blanket over it. A disquieting point was that it had no base, directly rests on ground.

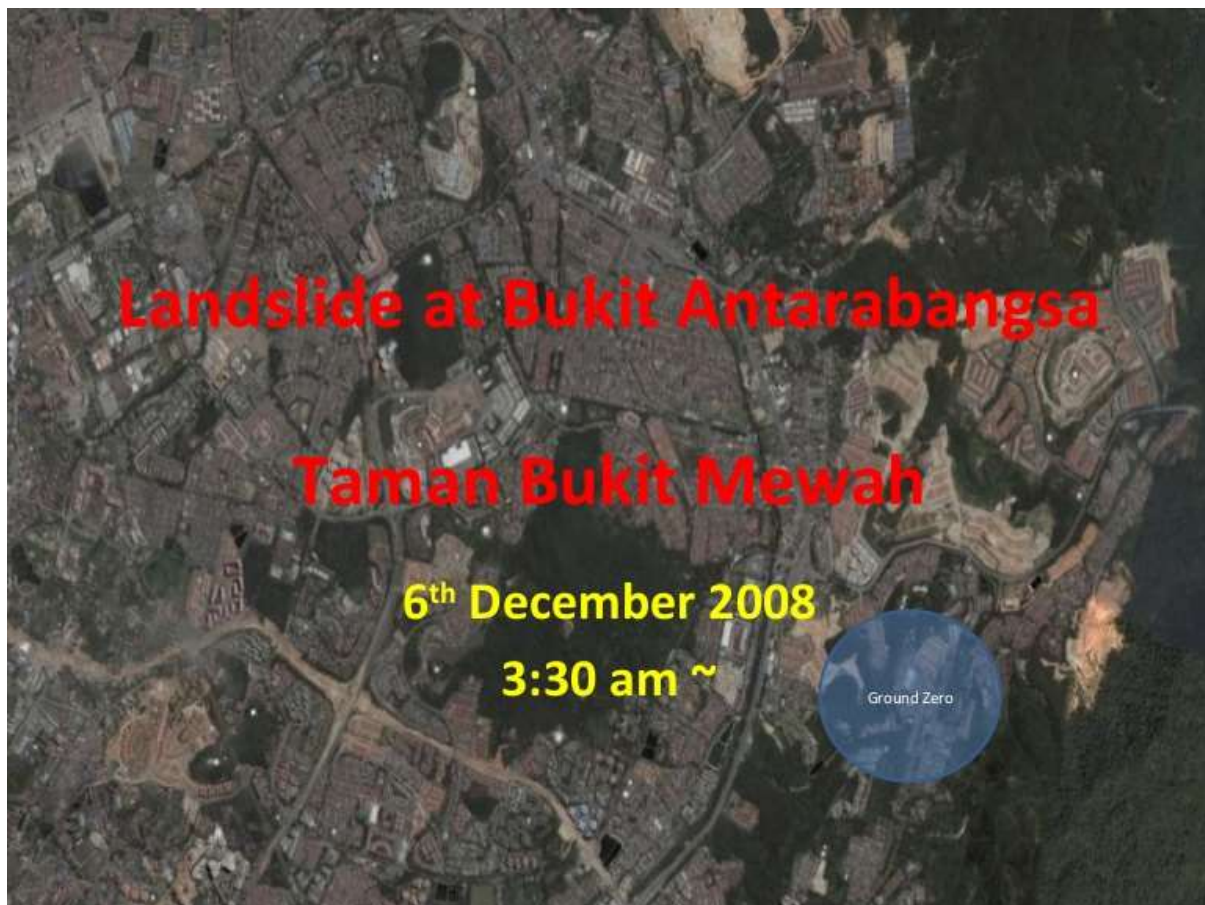
On 6th December 2008, a landslide was occurred at Taman Bukit Mewah, Bukit Antarabangsa, Hulu Kelang, Selangor. The landslide took place around 3.30 a.m., having 109 m in width at the crest, 120 m in length, 15 m in depth and the angle of the scarp of the crown ranges from 45° to 50°. It was observed that 101,500 m³ of earth had translated and the maximum run out distance of the failure debris was 210 m from the toe of the slope.

MPAJ reported about Bukit Antarabangsa (2008), (quite latest landslide) that leaking pipelines near Jalan Wangsa 11 very close to the landslide area are responsible to build up water pressure in the soil pores. It is already pinpointed by the authorities that no signs of earth motion are shown in the seismic records so possibilities of
